# Servicing Your Radio

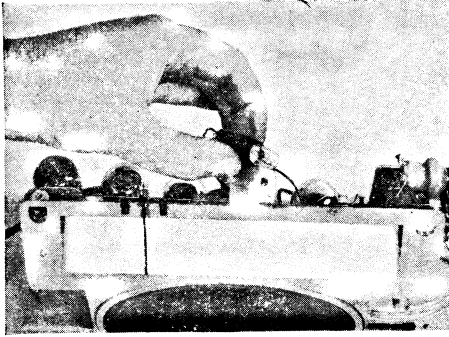
**CHANGING PILOT LIGHTS** is a simple operation in servicing a small A.C.-D.C. receiver, but be sure that you disconnect the radio at the wall socket—don't just turn off the switch. A serious short can occur if the pilot-light bracket and holder drop on the tuning condenser or chassis.

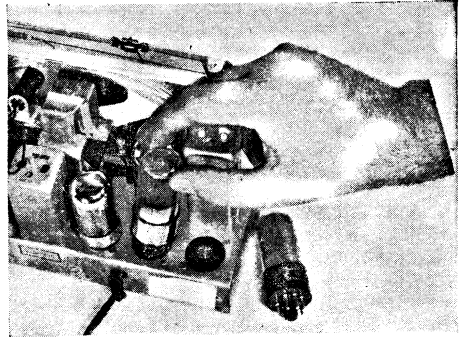
**INCREASED HEATER VOLTAGE** may be necessary if the rectifier tube burns out quickly on an A.C.-D.C. radio having a new high-voltage heater tube and no line-cord resistor. Try replacing the 35Z5-GT/G rectifier tube with a 45-volt rectifier, such as a 42Z5-GT/G, to increase the heater voltage to 120 volts.

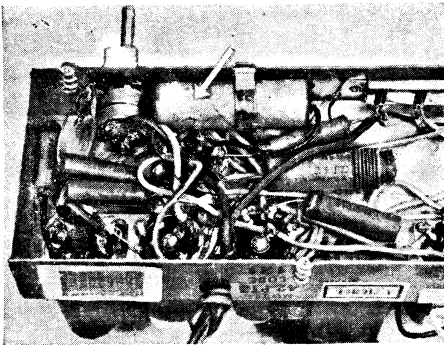
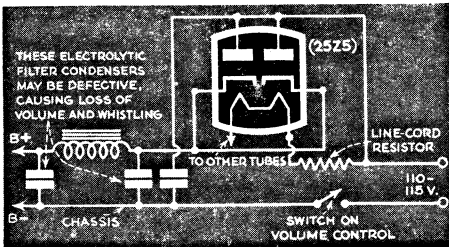
**SQUEALING AND WHISTLING** that make it impossible to tune in a station clearly on a small A.C.-D.C. receiver may mean failure of one or both of the filter condensers shown in the photograph above and the diagram below. The noise is usually accompanied by a noticeable loss in volume. If defective, the condensers must be replaced.

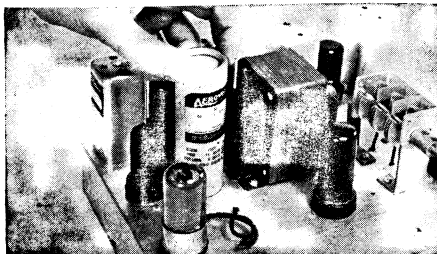
Electrolytic condensers go bad for many reasons—they may have open or short circuits, or the wet type may dry out and lose effective capacity. In any case, the best bet is to get a new condenser

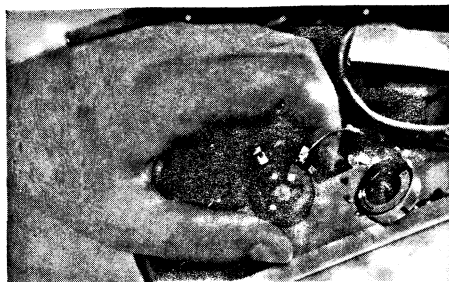
**NOISY VOLUME CONTROL** caused by the graphite wearing down or becoming coated with a hard film during the constant traction of the moving arm may be easily adjusted. Worn graphite can be restored with a dab of special liquid graphite lubricator. Film may be scraped away with a small screwdriver. Do not use a knife—it is too sharp—and do not scrape too hard.

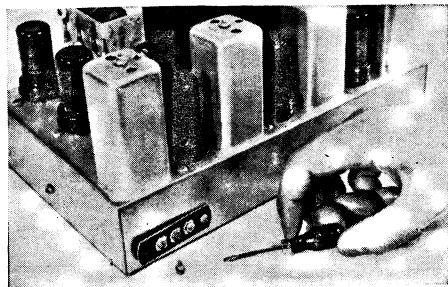
**WHEN TUNING-STAGE ALIGNMENT**, especially at the upper end of the dial, is not possible with a receiver using a loop antenna, reception may be improved in some cases by connecting a fixed condenser (.002 to .02 mfd.) across the loop antenna and ground, or by shorting the two.

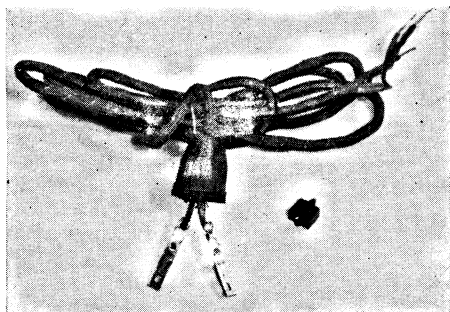
Yanking on a line cord often causes a break in the resistor wire. To avoid this, grasp the plug when removing it

**LINE-CORD BREAKS**, which occur most frequently in the built-in resistor in a cord of the type shown at the left, may be the reason a receiver goes dead. It is advisable to check this resistor if tests show that all the tubes are good. Sometimes it is possible to solder the thin resistor wire back to the prong, as shown in the sketch; if not, the whole line cord must be replaced.

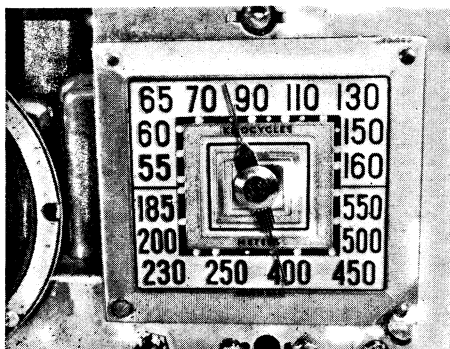
**SOME TYPES OF DIAL POINTERS** can be repaired easily with common liquid cement. If one cannot be set on the proper station indicator because it has come loose from the center plastic piece to which it was attached, remove the chassis from the cabinet and apply the cement as indicated in the drawing below. Best results can be obtained by removing the pointer assembly from the dial face and laying it flat, as shown. This will keep excess cement from spotting the dial face should any drip off the pointer during the application.

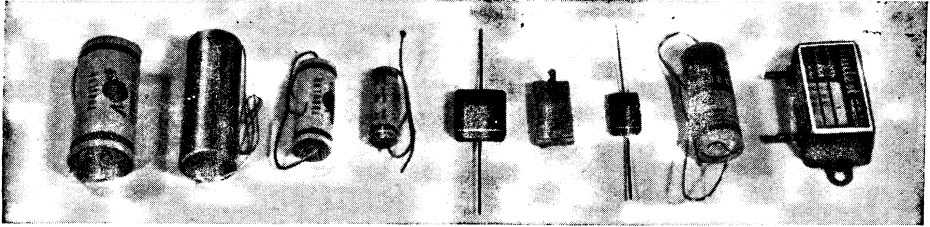
**FIXED CONDENSERS.** Nine types commonly used, left to right: .5-mfd. paper condenser; 8-mfd. midget electrolytic condenser; two (.05 and .02-mfd.) small paper condensers; three mica condensers (.002, .00075 and .0001-mfd.); a 50-volt, 25-mfd. electrolytic condenser; and a 1-mfd. paper condenser in a steel shell

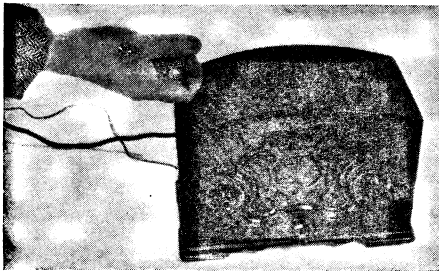
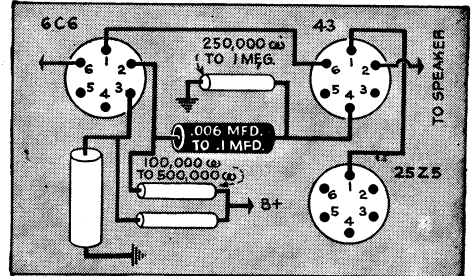
**IF RECEPTION STOPS** suddenly and resumes when the cabinet is knocked, the cause may be a loose connection or a bum tube. Or it may be a bad audio coupling condenser. This looks like the .05 or .02 paper tubular shown above. Diagram shows location. Before replacing, connect an .05 across it for a test

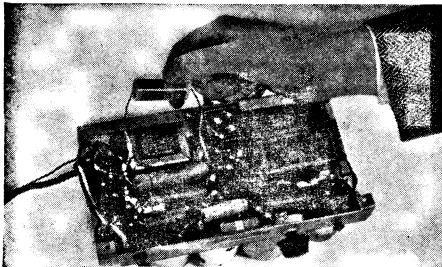
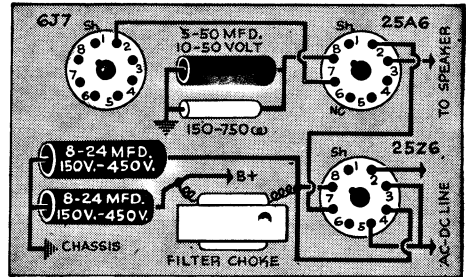
**HUMMING** is usually due to a faulty electrolytic condenser like the 50-volt, 25-mfd. shown above, across the power-tube bias resistor, or one like the 8-mfd., in the filter circuit. Connect an 8-mfd., 450-volt condenser across each electrolytic condenser in the set until the faulty one is found, and replace it

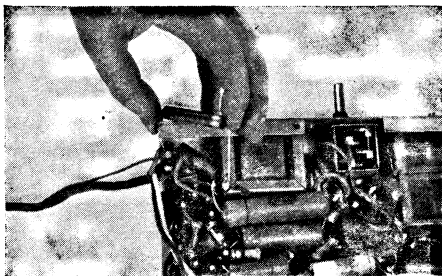
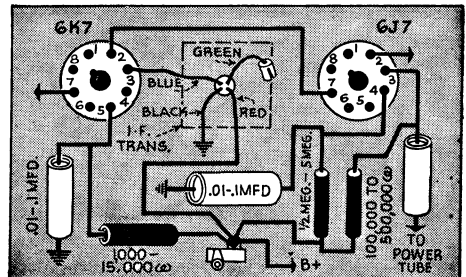
**FADE-OUT** experienced on many old sets is due to a fixed carbon resistor that has become crystallized. It usually can be recognized by a coating on its surface. If not, try connecting a 50,000-ohm, 2-watt resistor across each carbon resistor in the B+ circuit. If playing resumes, replace with one of correct value

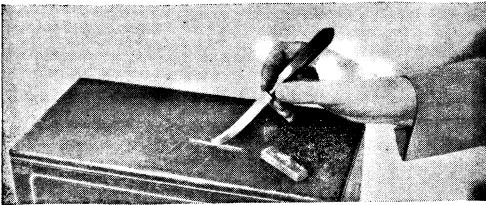
Deep scratches and dents are filled with stick shellac

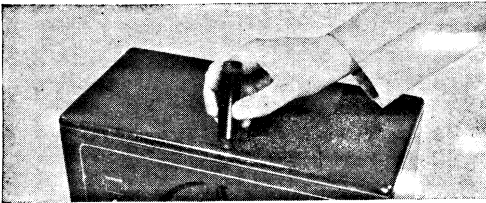
... while slight ones are removed by a special polish

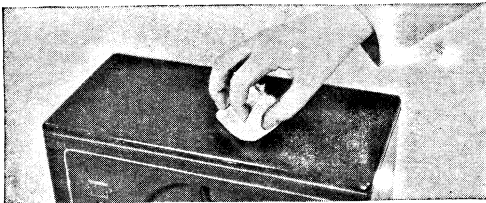
French polishing can be done with new synthetic materials

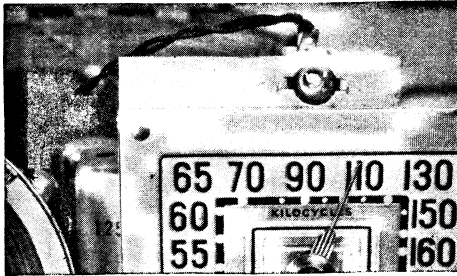
**REPLACE THE POWER PENTODE TUBE** if the pilot light goes on and then immediately goes off again each time the receiver is turned on. The trouble is a faulty heater in the 50L6GT tube. It makes proper connection inside the tube when cold, but when it warms up the contact is broken.

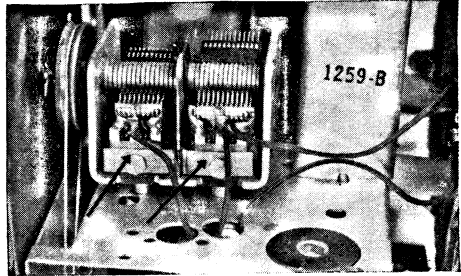
**1,600-KC. STATIONS CAN BE BROUGHT IN** on an old AC-DC midget set by readjusting the trimmer on the oscillator tuning condenser. The capacity is reduced a sixteenth of a turn at a time by loosening the nut shown at left above. Then loosen the nut on the other condenser to increase volume.

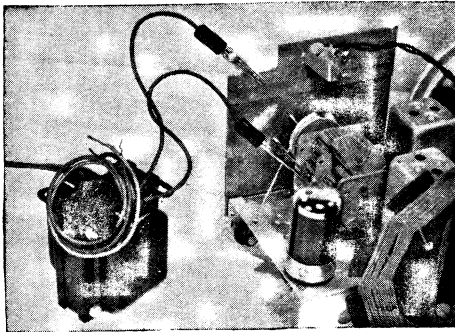
**NOISY TUNING IN THE LATEST RADIOS** may be caused by filings between plates of the oscillator tuning condenser. These may be burned out by connecting the secondary of a 700-volt power transformer across the condenser, as shown above and in the diagram. Be sure to disconnect the house current and the grid connection to the oscillator unit.

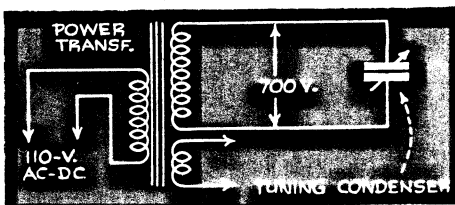
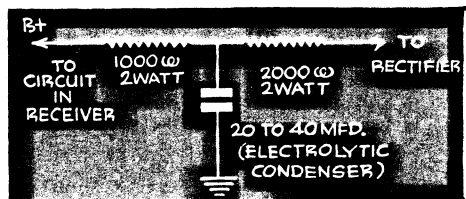
**THIS SIMPLIFIED FILTER CIRCUIT** for a midget AC-DC receiver uses only one electrolytic condenser, and may prove worth substituting when servicing a filter circuit that contains two or more electrolytic condensers if replacements for these condensers are hard to obtain. The diagram below shows how the substitute wiring is done.

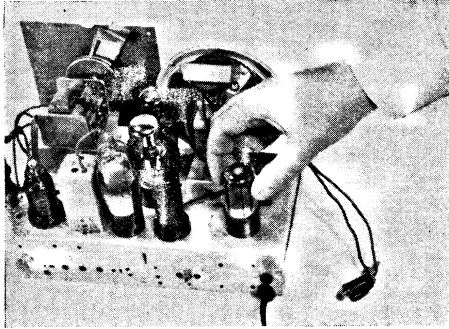
**WORK CAN BE SPEEDED UP** in servicing old radios with this gadget made from wooden photo tongs, such as is used on wet prints. Switch on the receiver and begin shorting the different fixed resistors. When the defective one is shorted, reception improves.

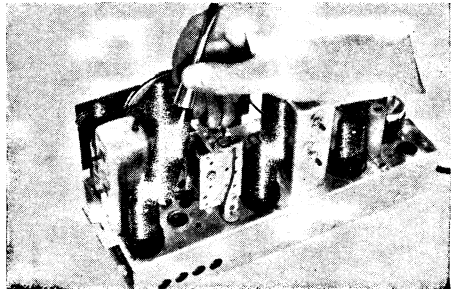
**A HANDY DEVICE TO HAVE** on the workbench is this homemade neon condenser tester. It will work with either paper tubular or mica condensers of any capacity. If the condenser being tested is good, the neon will flash once. But if the condenser is leaky or shorted the neon will glow and sputter, showing it should be replaced. Tester works on DC or 90-v. battery.

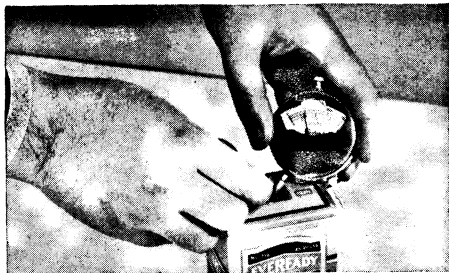
**TESTS ON BATTERIES** from a portable receiver should always be made with a voltmeter—it is the only testing instrument that will show accurately the effective voltage of a battery. It is risky business to use any other device, including a flashlight bulb or an ammeter, since many of them are likely to affect the life of a battery materially. An ammeter—especially bad to use for this purpose—has a low resistance and will short a battery when placed across it. Invariably it will also give a high reading even when a battery is badly run down.

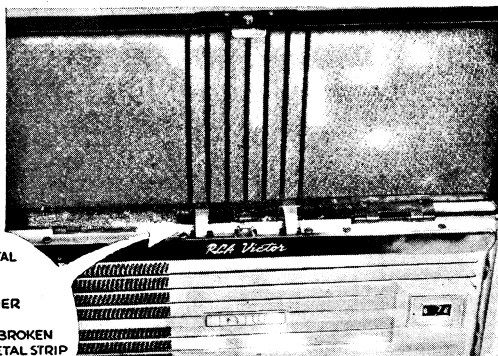
**STRIPS CONNECTING THE LOOP ANTENNA** inside the cover of some midget portable receivers are likely to wear and break off near the hinge as a result of frequent opening and closing of the lid. When such a break occurs, reception stops. These metal strips can be repaired, however, with short lengths of twisted metal cord like that used in repairing radio dials. Remove the broken part of the original metal strips at their connection with the two wires inside the set; then solder one end of the cord to each of these wires, and solder the other end to that portion of the strips connected to the antenna.

Where a loop-antenna connection is likely to break, Repair it as shown at the left

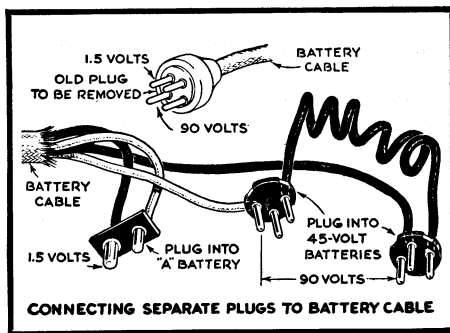
**THREE SEPARATE PLUGS** can be substituted for a single battery-pack plug, as shown in the drawing below, to permit use of separate "A" and "B" batteries with a portable if a battery pack cannot be obtained. In removing any plug from a battery, always grasp the plug itself. Never tug on the wire, for this may pull the insulation back, and a short caused by wires touching can render a battery useless in 15 minutes.

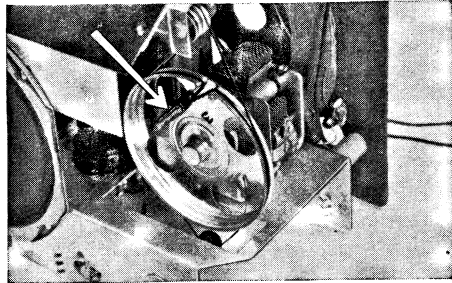
In some friction-drive dials, the cord is kept taut by a spring behind the dial plate as shown above. To tighten the cord, it is necessary only to remove the spring and make another knot in the drive cord

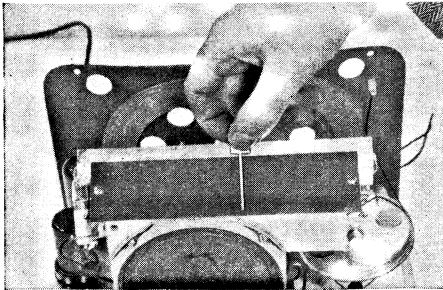
If the pointer is not calibrated properly with the frequency marks on the dial, it is an easy matter to move it to the correct position. Once it is set properly for one station, it will be correct for all

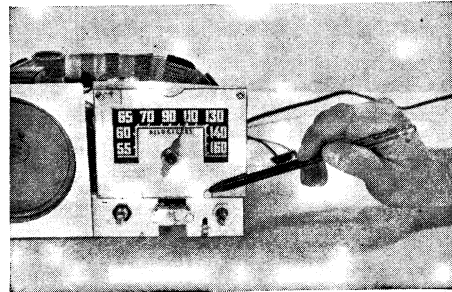
To get at a spring behind the dial plate as shown in the photograph above, it is necessary to take off the plate. To do this, loosen the two hex nuts indicated by the pencil in this illustration

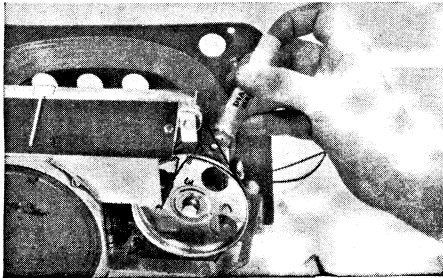
A slipping belt, when it is not too serious, can be remedied by applying a special wax obtainable in stick form. Rubbed lightly on the belt as shown, it usually is found to give a smoother-working dial

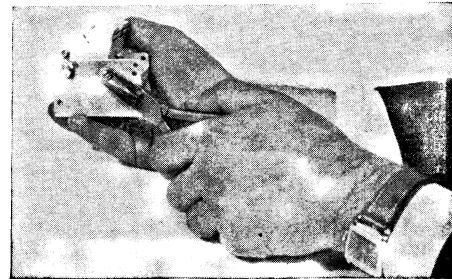
If moving plates touch fixed plates in a tuning condenser, loud static is produced whenever the dial is touched. On most condensers this can be corrected by adjusting with a screw and lock nut
